# Double Strike for Firetrace

**Double success for Firetrace automatic suppression systems**

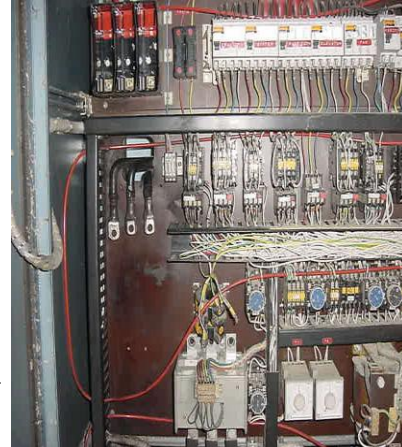
The on site engineers were first alerted last week when the Firetrace panel went into alarm . On investigation of the offending switchgear, it was discovered that a 200 Amp circuit breaker had faulted causing a fire within one of the Grinder control panels.

Due to the unique sensing properties of the Firetrace tubing ,the fire was detected and extinguished so quickly that no other components were damaged.

Plant manager, Philip Milton said "The system performed brilliantly. The damage to the panel was limited to the faulty breaker only. No other components were damaged and production was resumed within three days.

*Above: Minimal damage to panel*

Firetrace Limited attended site and replaced the system within the three day shut down.

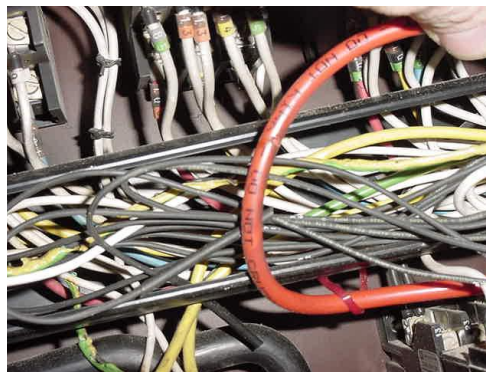
On arrival the Firetrace engineer discovered that a second fault had occurred within the panel causing the wiring to overheat.

*Above: Burst tube following overheated cable*

The Firetrace unique method of detection had this time limited the damage to only a few wires. These were quickly replaced and the source of the problem was rectified.

The Firetrace system was also replaced and the panel was back on line the same day.
